Automobile Status Report

2011 Toyota CAMRY

VIN 4T4BF3EK6BR205614

Multi-Point Inspection Checklist

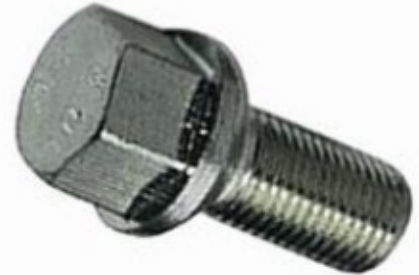
Wheel Fastener

Wheel Fastener: Four standard lug nuts. Has anti-theft installed - have key.

If stripped, missing rusted or damaged in any way the wheel fasteners must be replaced. the wheel fasteners are the only objects holding your tire on your car. If left unfixed the wheel may become loose causing a major safety concern.

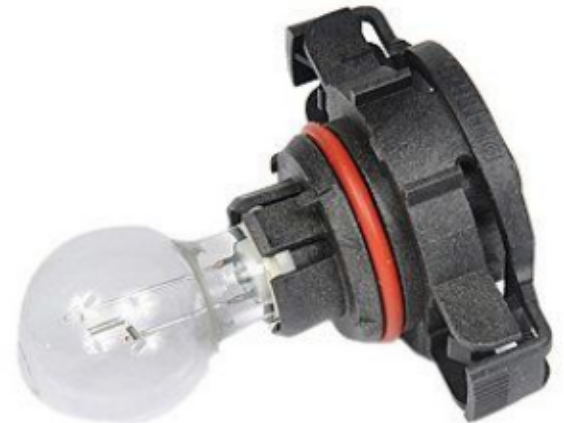
Headlamp Replacement

Bulb - Headlight (Bulb Only): Right low beam is out.

If not repaired, the headlight will not function. In many states, this is a violation of the law and the automobile will not be able to pass safety inspection. This also poses a serious safety threat when operating the vehicle at night, in precipitation or in a low light settings. If a headlamp bulb is not operable, then visibility will be impaired in these conditions.

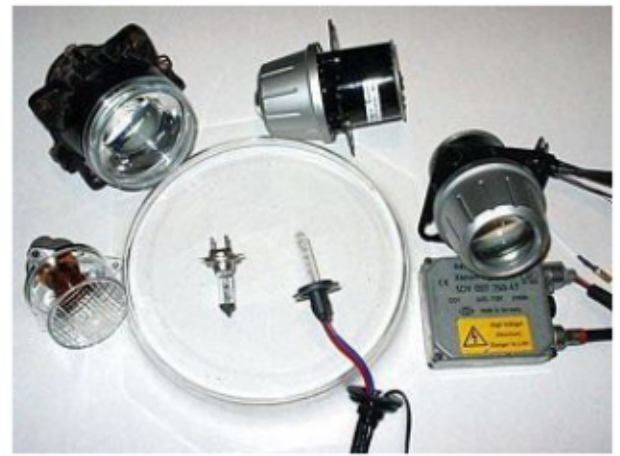
Bulb - Park Lamp: Both front parking lights are out (located above turn

signals).

If not repaired, the park lamp will not illuminate when the turn signal is activated. This can pose a safety threat when operating the vehicle and in many states will prevent the vehicle from passing safety inspection if not functioning properly.

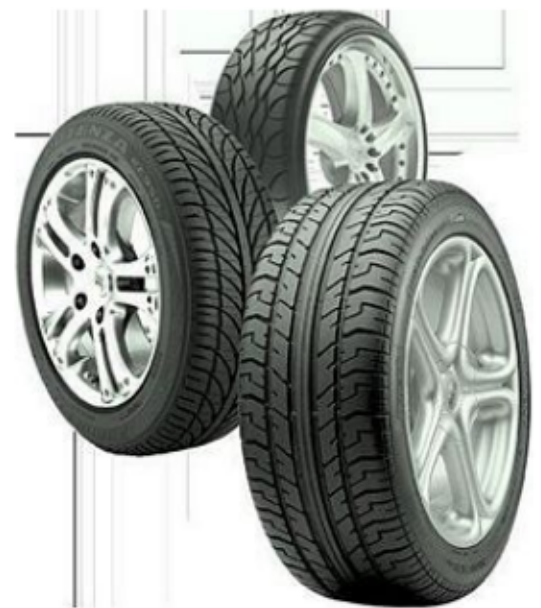
Tires

*Tires - 4: 215/60R16 - 4/32, Chopped wear

According to most states' laws, tires are legally worn out when they have worn down to 2/32" of remaining tread depth. As a tire wears it's important to realize that the tire's ability to perform in rain and snow will be reduced. With 2/32" of remaining tread depth, resistance to hydroplaning in the rain at highway speeds has been significantly reduced, and traction in snow has been virtually eliminated. If rain and wet roads are a concern, you should consider replacing your tires when they reach approximately 4/32" of remaining tread depth.

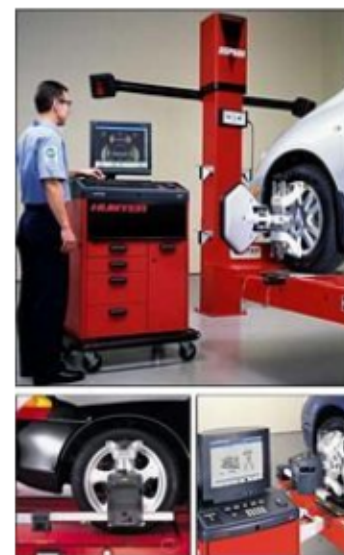
Alignment

*Alignment

If not done, you will see uneven or rapid tire wear, pulling or drifting away from a straight line, and wandering on a straight level road. It can also cause extra load on certain suspension components, making them more likely to fail.

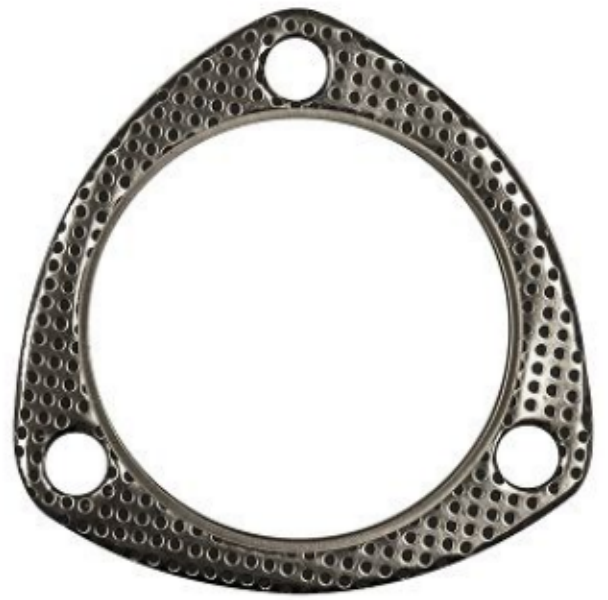
Exhaust - Flange Gasket: AND hardware: Exhaust leak at flange between front pipe and pre-silencer.

A faulty or broken flange gasket will allow exhaust gases to leak out as opposed to moving through the

exhaust system as intended.
