Automobile Status Report

2015 Honda ODYSSEY

VIN 5FNRL5H28FB067800

Multi-Point Inspection Checklist

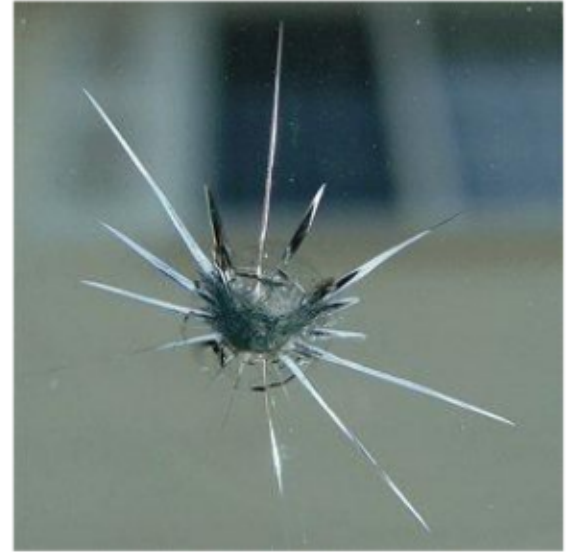
Windshield Chip Repair: Driver's side.

Every rock chip will eventually crack out, and it is hard to determine how long any chip can hold until the damage is too large to repair, but if that little chip spreads, it will cost you a new windshield.

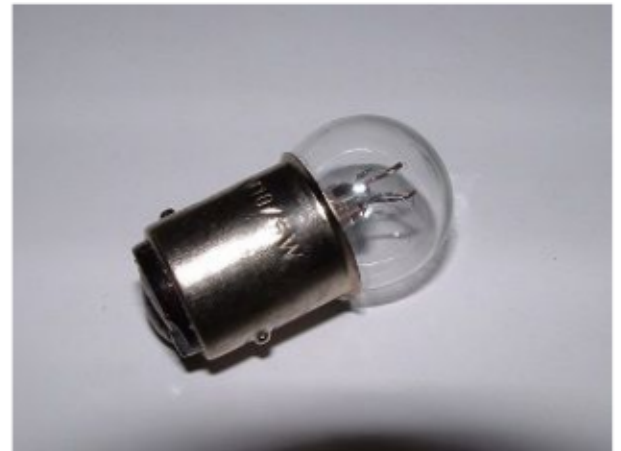
Bulb - Brake Light: Left

If not replaced, you will fail the vehicle inspection and could receive a ticket for improper equipment.

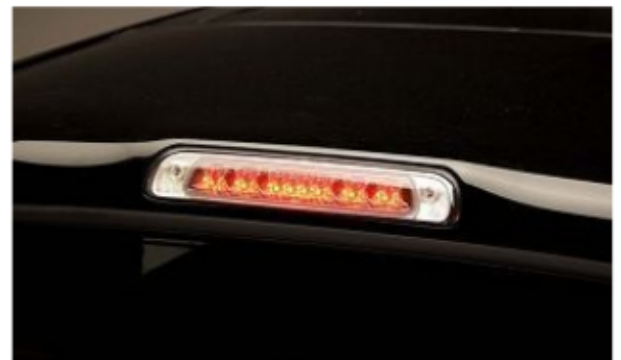
Bulb - Third Brake Light

An important added safety feature, and if not replaced, you will fail the vehicle inspection and could receive a ticket for improper equipment.

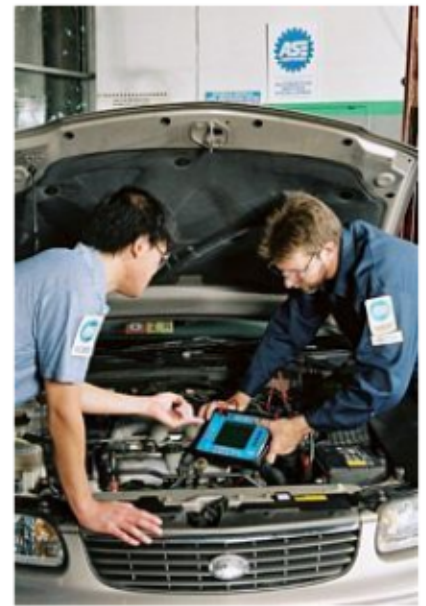
Diagnostic: Engine oil leak (3, Forming drips at bottom of A/C compressor and bracket). Spool valve?

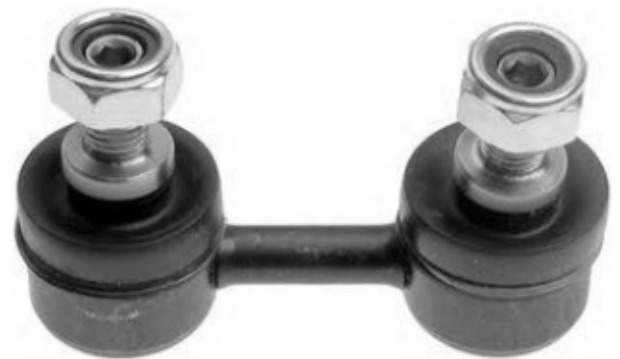
Sway Bar Links - Front: Loose and rattling.

If the Sway Bar Links are found to be damaged or broken the sway bars effectiveness is reduced or eliminated, resulting in a "loose" feeling in the front

end of the vehicle. Potential problems include abnormal tire wear and extra stress to various other suspension components.

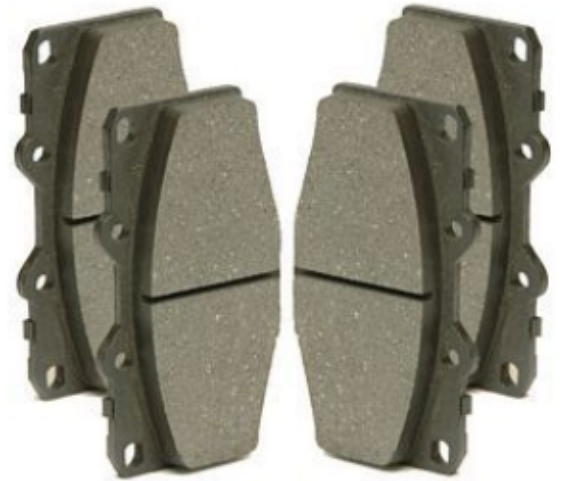
Brake Pads Replacement Only - Rear: 4mm

Brake pad material wears out over time. Brake pads should be periodically inspected for wear, which is highly variable depending on vehicle weight and driver habits. Brake pads must be replaced before the friction material is worn away completely. If it isn't, metal-to-metal contact will occur between the brake rotor and the worn-out brake pad. If metal-to-metal contact occurs, the brake rotor will be damaged, and it will need to be resurfaced or replaced.

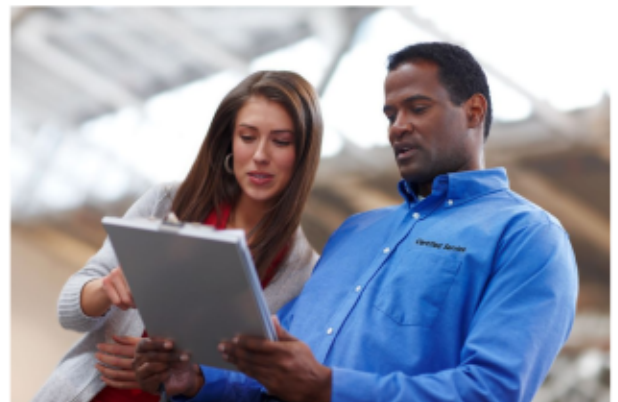
[Other]: FRONT VALVE COVER GASKET IS LEAKING.
